# Fiber Orientation in Fiber-Reinforced Plastics and How it Affects Automotive Applications

E. M. Rowbotham  
Ford Motor Co., Ltd.

Automotive Engineering Congress  
Detroit, Mich.  
February 25 - March 1, 1974

740264

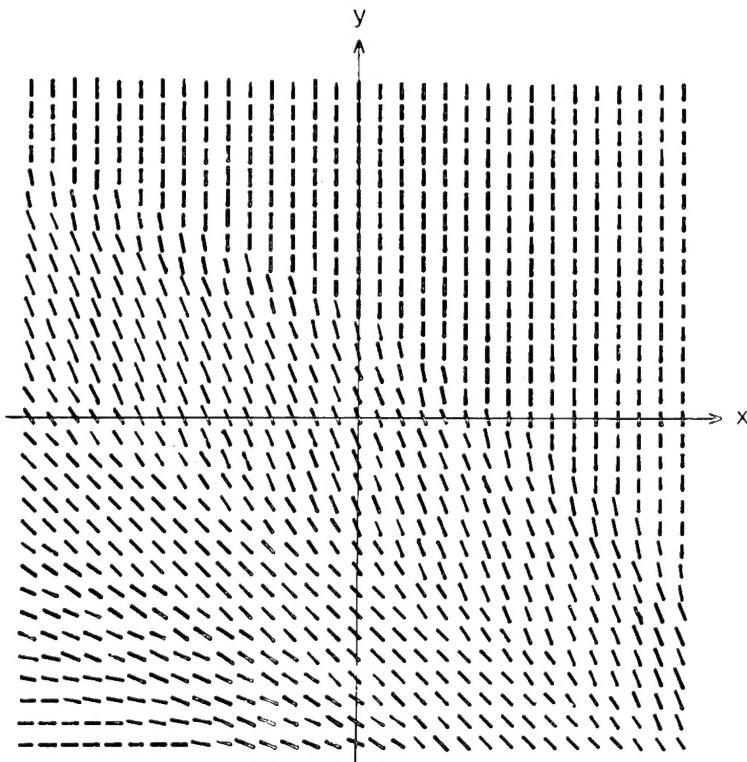
Fig. 2 - Schematic representation of preferred fiber orientation deduced from analysis of strength

From microscopic examination of the fracture surface, we were able to obtain a measure of the angle the fibers made with the specimens axis and consequently with the X-axis. By correlating the angle of the fiber with the strength measured and the position of the specimen in the plaque, we were able to map (Fig. 2) the fiber pattern within the plaque and also estimate the extent to which fiber orientation was contributing to the resulting scatter—75% could be attributed to fiber orientation.

Fig. 2 shows the fiber pattern predicted from the test results. This particular pattern is unusual, in that it portrays a fiber pattern normally associated with a quarter section of a square plaque. However, the fiber pattern will only repeat itself if all the factors involved in the molding are reproduced. For instance, the fiber pattern can alter due to the positioning of the molding charge in the mold cavity or even to the cocking of the upper press platen during mold closure. Anything that produces different flow characteristics of the molding charge can create variations in the fiber orientation obtained.

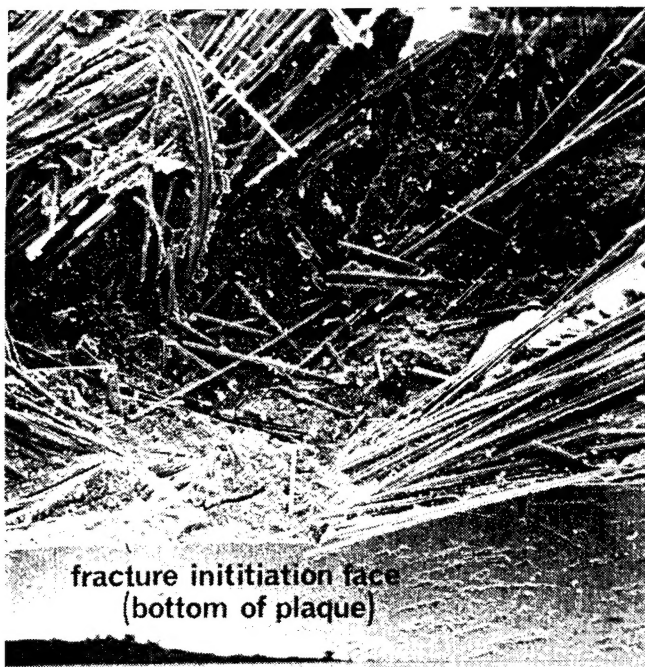
Fig. 3 - Fracture surface of low-strength specimen, stereoscan micrograph, X40 reduced 55% for reproduction

Fig. 3 is a stereoscan micrograph of the fracture surface of a low-strength specimen. It will be observed that fiber orientation lies predominantly perpendicular to the specimen's axis. A stereoscan micrograph of a high-strength specimen's fracture surface (Fig. 4) showed the fibers oriented parallel to the specimen's axis, while in Fig. 5, a medium-strength specimen depicts the fibers angularly disposed between the longitudinal and transverse axis of the specimen. Fibers so aligned will only partially contribute to the overall strength of the test piece.

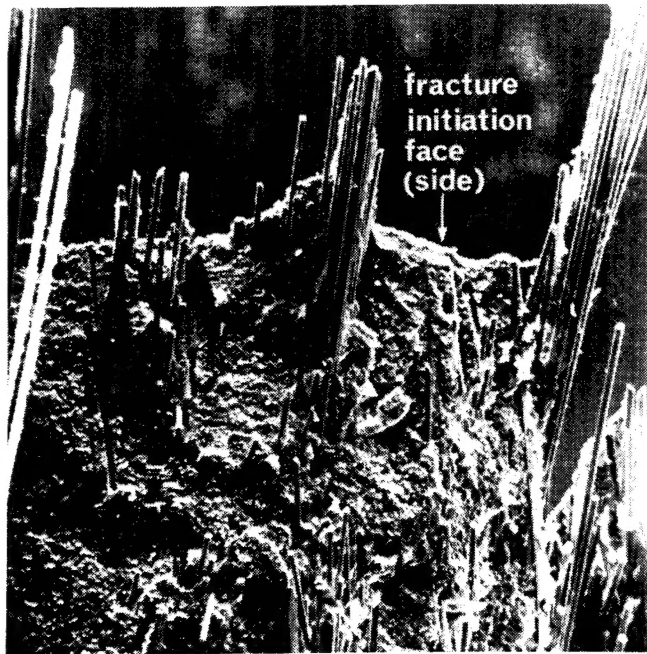
Fig. 4 - Fracture surface of high-strength specimen, stereoscan micrograph, X85 reduced 55% for reproduction

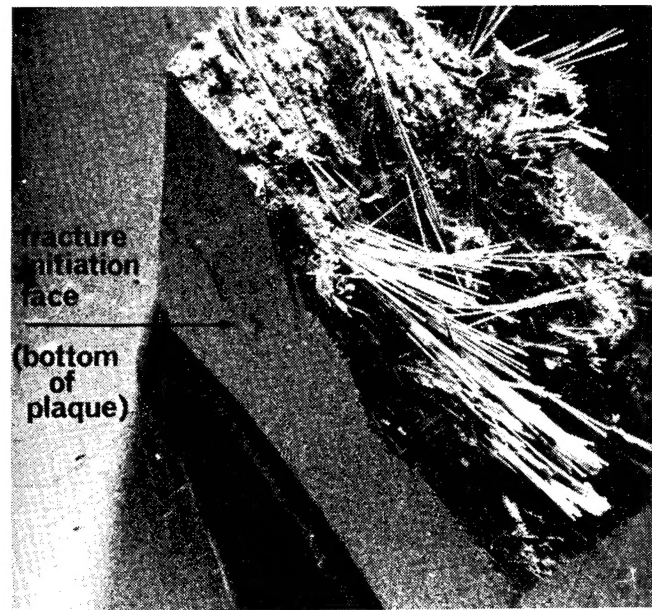
Fig. 5 - Fracture surface of medium-strength specimen, stereoscan micrograph, X15 reduced 55% for reproduction

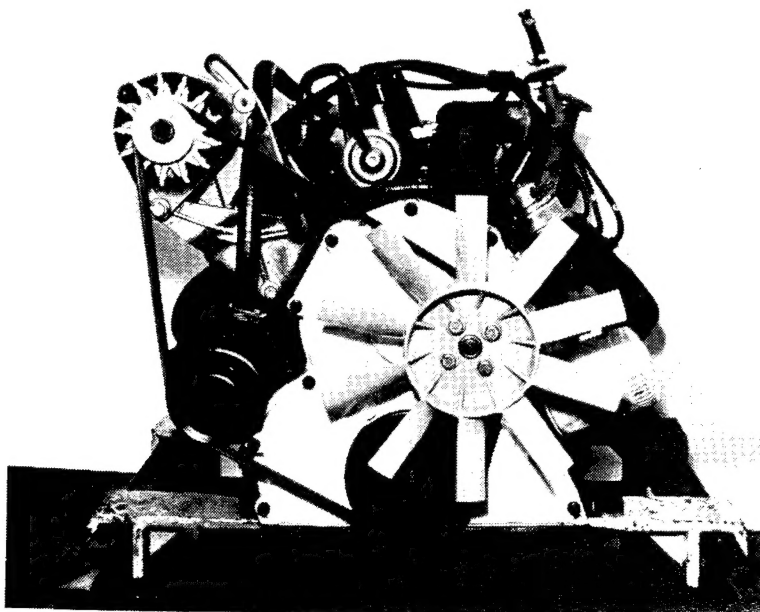
Fig. 6 - Front timing cover assembled to engine

was made from 20% glass DMC (6 mm fiber length). The design was basically the same as its aluminum counterpart with only minor modifications such as slight thickening of the molding's outer periphery, inclusion of an extra reinforcing web at the root of the radiator fan boss, and omission of the circlip access aperture, normally included when mechanically fixing the radiator fan bearing. It is a functional component supporting the fuel pump, radiator fan, and bearing. The oil sump is bolted to the molded inserts located in bosses on the bottom sealing flange. Operationally, the component is subject to both static and dynamic stress. The fatigue stress is illustrated in Fig. 7. All tests were carried out on a 500 h engine hot test (Appendix A), inspection being made every 50 h. Tests were terminated depending upon where and to what extent cracking had occurred. Sections of the molding were cut and etched (Appendix B) to reveal the fiber orientation associated with the failure.

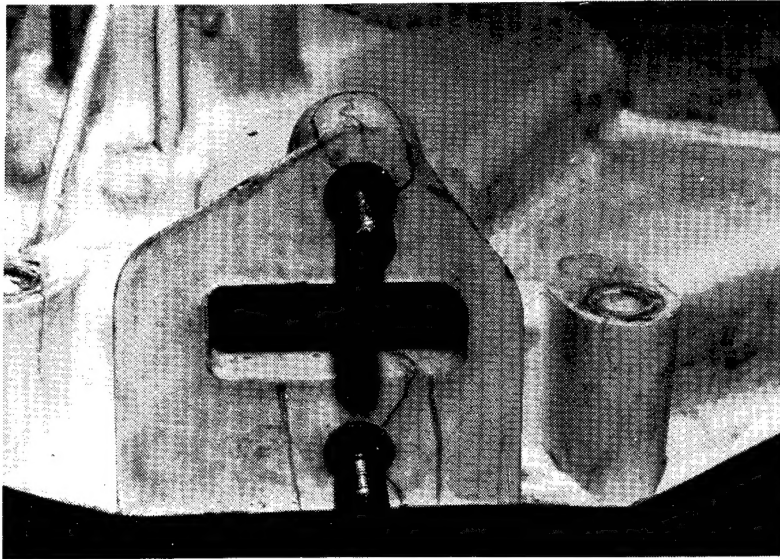
**FUEL PUMP FLANGE** - This flange was particularly vulnerable to cracking (Fig. 8). The geometry of this molding section with its retractable core and inserts created a characteristic flow in the material during molding. Etched sections (Fig. 9) showed how the material flow separated into two streams on either side of the retractable core, joining together again on either side of each of the two inserts to form a characteristic weld line. The glass fiber followed the flow, orienting itself parallel to the weld line. The glass fiber never bridged the weld line. Cracking occurred either at the resin weld line or parallel to it, following the fiber orientation on either side of the insert. Of the 36 moldings tested, only one did not fail in this manner.

Fig. 8 - Front timing cover fuel flange showing typical cracking

Redesign and change in the molding technique is currently being undertaken to obviate failure; for example, placing molding material, SMC or DMC, into this section of the mold cavity prior to molding, thus reducing the flow of the material; or, delaying the placement of the core and the inserts until the mold is full but while the material is still in an uncured condition.

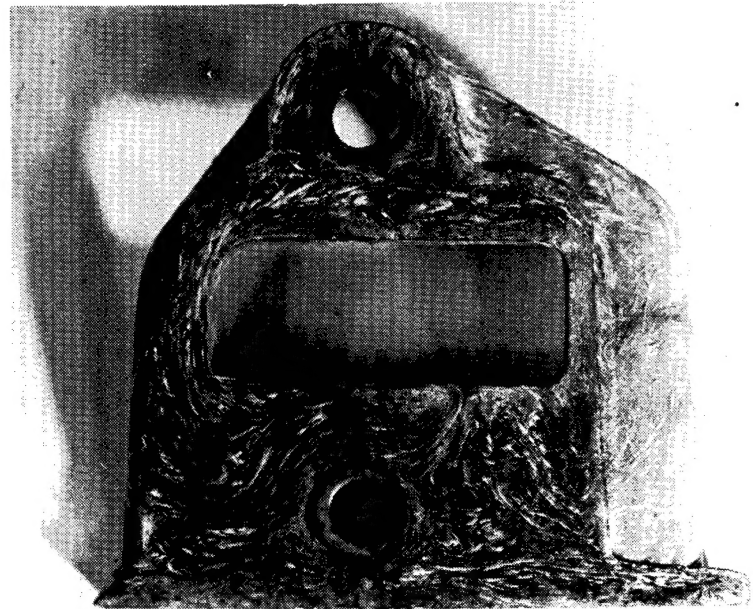
Fig. 9 - Front timing cover fuel flange etched to show fiber orientation

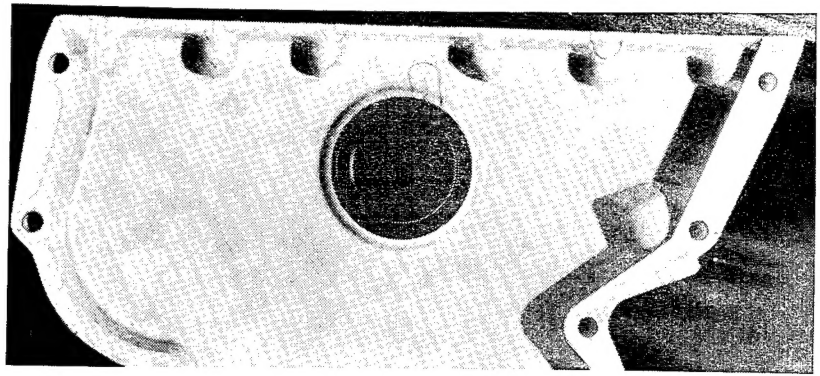
**OIL SUMP BOSSES** - Cracking of the oil sump bosses (Fig. 10) was generally present but not always in an identical position. Etched sections of the bosses (Fig. 11) showed a weld line across the top of the boss and fiber orientation parallel with the axis of the insert around the boss periphery. Cracking followed any line along the fiber orientation. No problem was experienced with the weld lines occurring on the top of the bosses because no adverse stress appeared to be present. The fiber orientation was obviously occurring due to the flow of the material around the insert. The close proximity of the insert to the molding tool wall caused the material, during flow, to be subjected to shear forces from the tool surface as well as from the inserts' surface. A combination of both of these shear forces did not allow any random fiber orientation in this comparatively thin section of molding. Delaying the placement of the insert until material flowed into the boss area and then forcing the insert into the still-uncured material could resolve this problem.

Fig. 10 - Front timing cover oil sump support bosses showing typical cracking

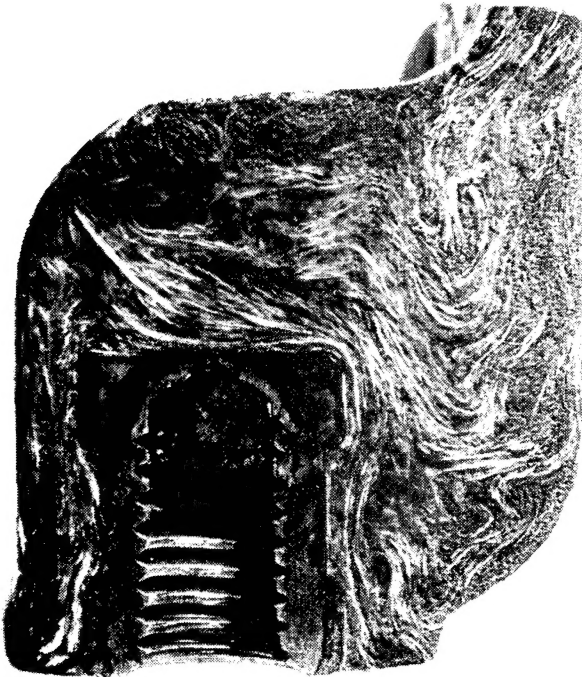
Fig. 11 - Front timing cover oil sump support boss section etched to show fiber orientation

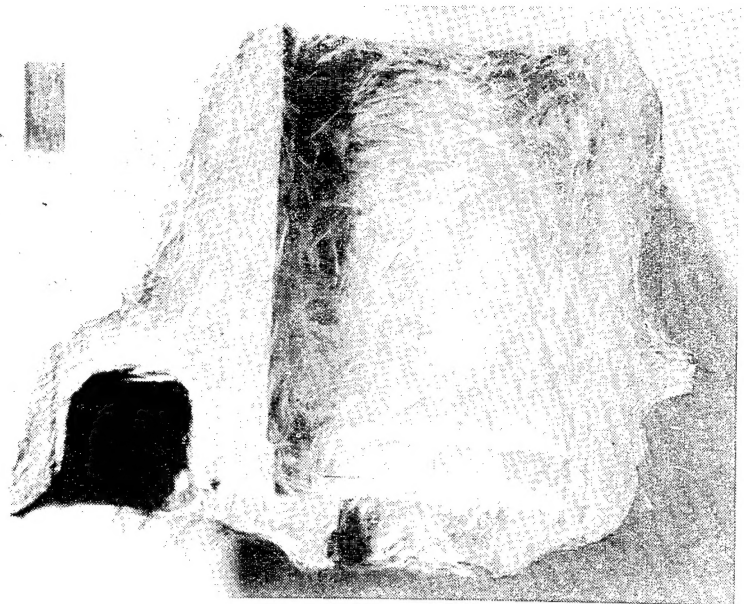
**RADIATOR FAN-BEARING HOUSING** - Cracking occurred in the fan-bearing housing either when pressing in the bearing or during engine test. When cracking occurred, fiber orientation was always aligned axially to the bearing (Fig. 12), which was adverse to the hoop stress operating on the fan-bearing housing.

Fig. 12 - Front timing cover fan bearing housing section etched to show fiber orientation

Random fiber orientation could be achieved by lining this section of the mold cavity with SMC material. The SMC, being randomly oriented and not required to flow any distance during molding, did not produce fiber alignment.

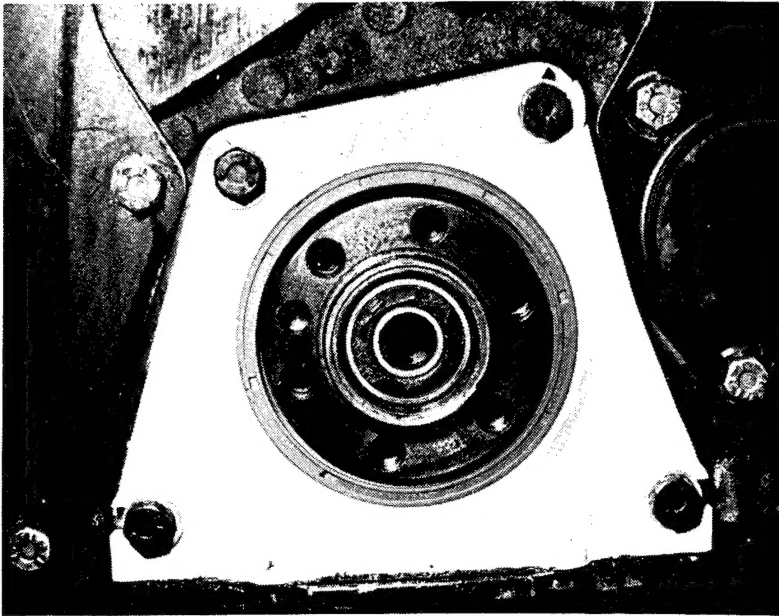
Fig. 13 - Crankshaft rear seal housing assembled to engine

The crankshaft rear seal housing (Fig. 13) supports the crankshaft rear-end rubber seal. Theoretically, the component is unstressed apart from the compressive loads produced when bolting it to the engine block. In practice, stress can also be applied due to a mismatch condition derived when assembling the oil sump pressing to the bottom of the molding.

although the design, at first sight could be equally good for plastic. Low-shrink DMC (15% glass, 6 mm fiber) was chosen for this component because of the need to maintain close tolerances and flatness. The DMC moldings were first tested on engine rig tests followed by vehicle trials. No functional failures were experienced with any of the moldings tested, although cracking occurred at the bolt holes and on the bosses. Etched sections, using the technique described in Appendix B, were prepared. Again, fiber orientation associated with weld lines was present around the four fixing bolt holes (Fig. 14). Cracking followed either the resin-rich area of the weld line or the fiber orientation running parallel with it.

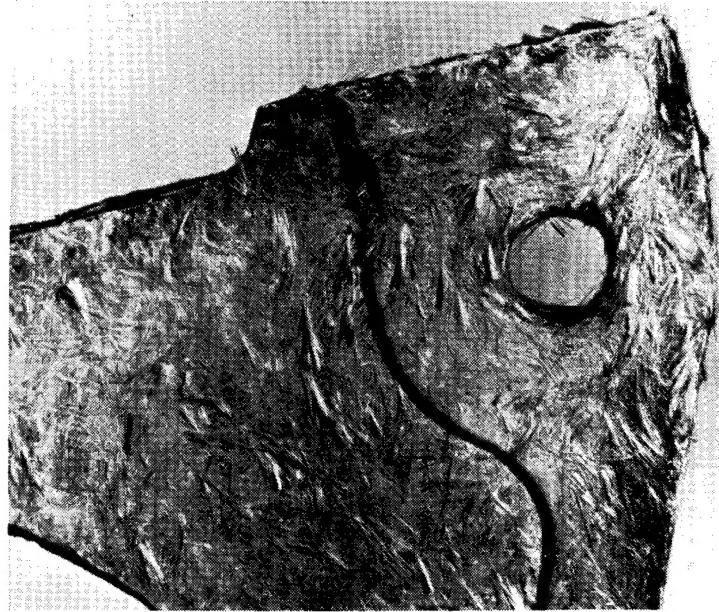
Fig. 14 - Crankshaft rear seal housing showing fiber orientation around molded-in fixing holes

The molding was molded without bolt holes present, the holes being jig-bored later as a secondary operation. While this obviated the orientation problem, it also invoked a cost penalty. Closer inspection showed that this problem could be rati-

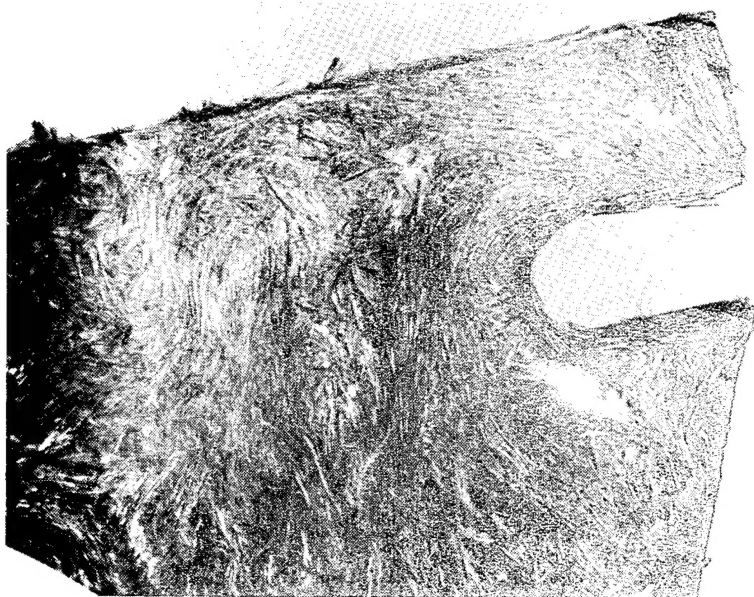
Fig. 15 - Crankshaft rear seal housing showing fiber orientation around molded-in fixing slot

fied by molding in slots instead of holes (Fig. 15). No adverse orientation was experienced with this technique, while the gasket seal face was still maintained, all at no additional component cost.

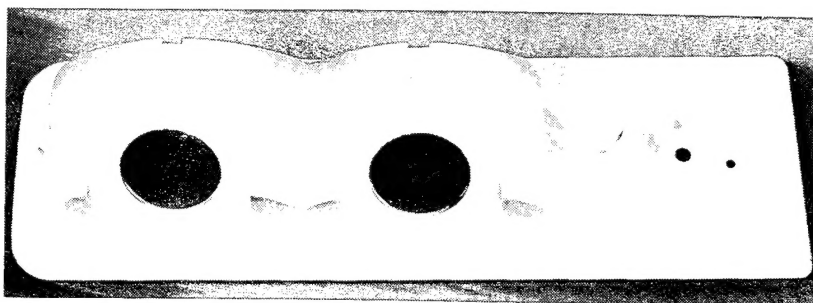
Fig. 16 - Rear tail lamp housing

Fig. 16 shows a molding of a rear lamp housing that has been injection-molded from 20% glass DMC, 6 mm fiber length. As can be seen in this molding, the sections are extremely thin; so the shear effects on the material during flow should be very high, thus producing gross fiber orientation. The etched surface of this molding (Fig. 17) shows almost complete random surface fiber orientation, apart from the slight swirl condition present around the feed sprue area. A section of this same molding with the surface skin ground off to reveal the material core shows the fiber orientation that was anticipated to occur on the surface (Fig. 18). The exact reason for this effect has not been elucidated. However, the internal forces in the flowing material must be greater than the frictional forces being experienced at the mold surface and must, therefore, become the controlling factor. Whether this is a function of the particular mold surface or the fact that the material, when injection-molded, is very close to its curing temperature and, thus, has a higher viscosity than compression-molded material, or that the material is being forced very rapidly through the mold, has not been established, but we suspect it is a combination of all these factors.

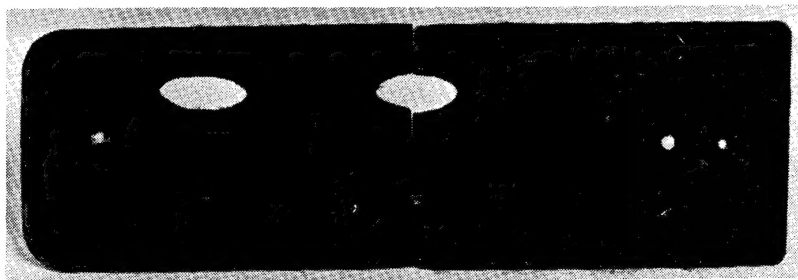
Fig. 17 - Rear tail lamp housing etched to show surface fiber orientation

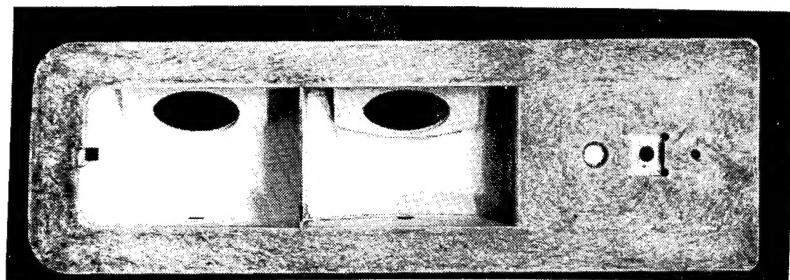
Fig. 18 - Rear tail lamp housing section showing fiber orientation in core

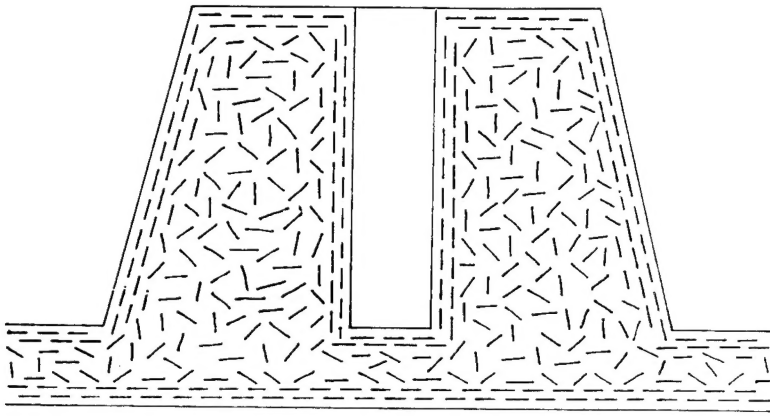
molded components, because of the high risk of stud misplacement during molding and the consequent very costly damage that can occur to the molding tool. The tendency is to mold-in holes and use either self-tapping screws or bolts that are capable of cutting their own thread. Pull-out loads and stripping torques for the screws/bolts can be very high and provide a very good method of assembly. However, the relationship between the hole diameter and the molded skin on the inside of the molded hole, which tends to contain adverse fiber orientation, is very important. Fibers tend to align themselves parallel to the molding pin axis, and, if the pitch of the self-tapping screw or bolt is insufficient to penetrate the skin and locate the thread in the randomly oriented core material, then the pull-out load and the stripping torque will be very low indeed. The decrease is generally of a factor of four magnitude. For maximum retaining strength, fiber must lay transversely with respect to the screws/bolts axis in the areas of thread engagement (Fig. 19).

Fig. 19 - Section through boss with molded-in hole indicating fiber alignment
